**NUCLEAR LAKE
A RESOURCE
IN QUESTION**

January 18, 1982

Prepared by:
Nuclear Lake Management Site Clearance Subcommittee
in cooperation with
The Appalachian Trail Conference
Dutchess County Cooperative Extension

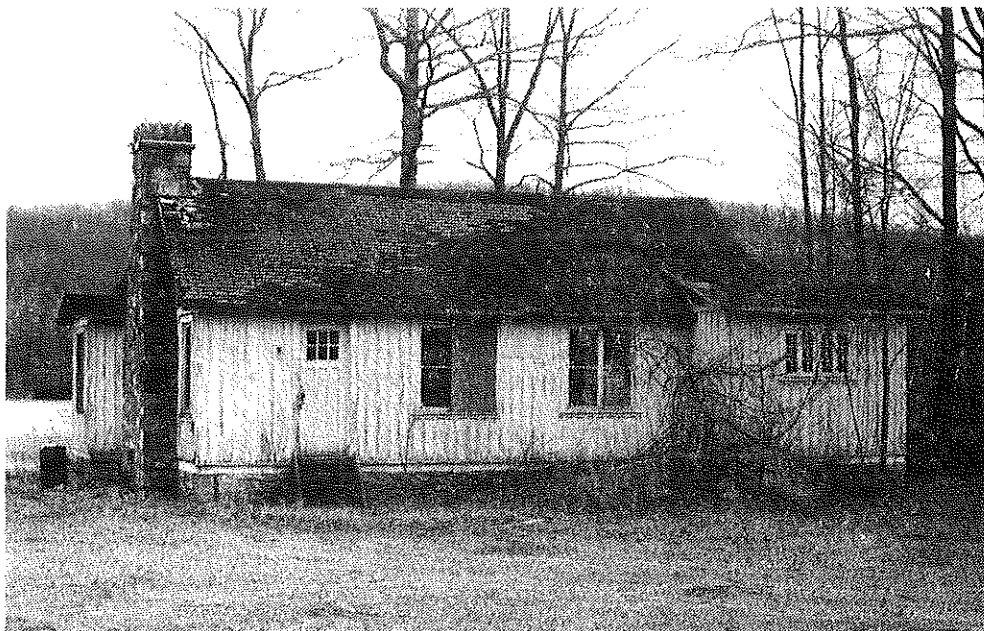
Figure III-3 - The Lodge (1981 Photo)

This single story "wooden hunting lodge" existed prior to 1955 (7). It has a stone foundation, stone fireplace, and is located near the lake shore south of the Plutonium Facility.

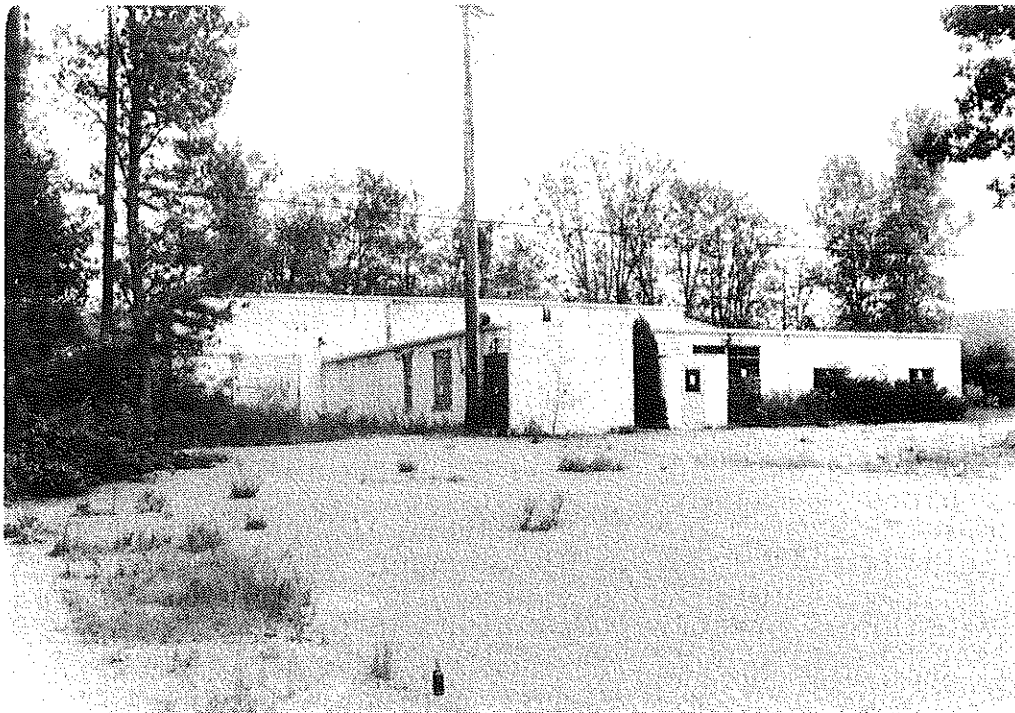
Figure III-4 - The Plutonium Facility (1981 Photo)

Several plans for alterations were reviewed between 1963 and 1966. During 1967, the detached Gas House on the northwest corner was removed and replaced by a 24' by 36' concrete block addition to the main structure. At the same time a 30' by 50' concrete block addition was constructed on the southwest corner. This required reconstruction of the sub-surface sewage disposal system (13, 14). Plans for this system were approved by the Dutchess County Department of Health in February 1967. It was constructed on the south side of the building, by June 1967, and included a 900 gallon tank and a leach field 5-7' deep (15, 16). After 1970, a 28' by 32' metal addition was constructed on the southeast corner of the facility.

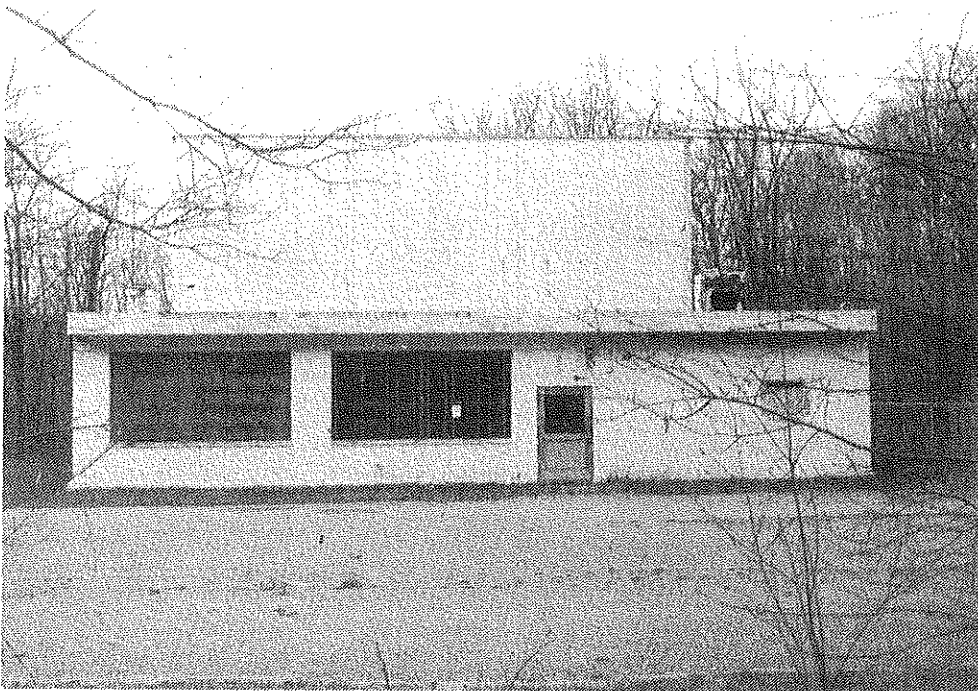
Figure III-6 - Critical Facility (1981 Photo)

Construction began in 1956 and there have been no apparent exterior additions. The building was constructed of "structural steel with non-load-bearing masonry walls". The west end of the building consisted of the 25' by 60' by 38' high reactor room. It had provisions for two reactor locations and had two concrete pits in the floor. These measured 10' by 20' by 10' deep and 8' in diameter by 8' deep, and both were constructed without drains. A 4 foot thick poured concrete shield wall separated the reactor room from the other parts of the building. The remainder of the building is one story concrete block. Both sections have flat reinforced roofs (24, 34).

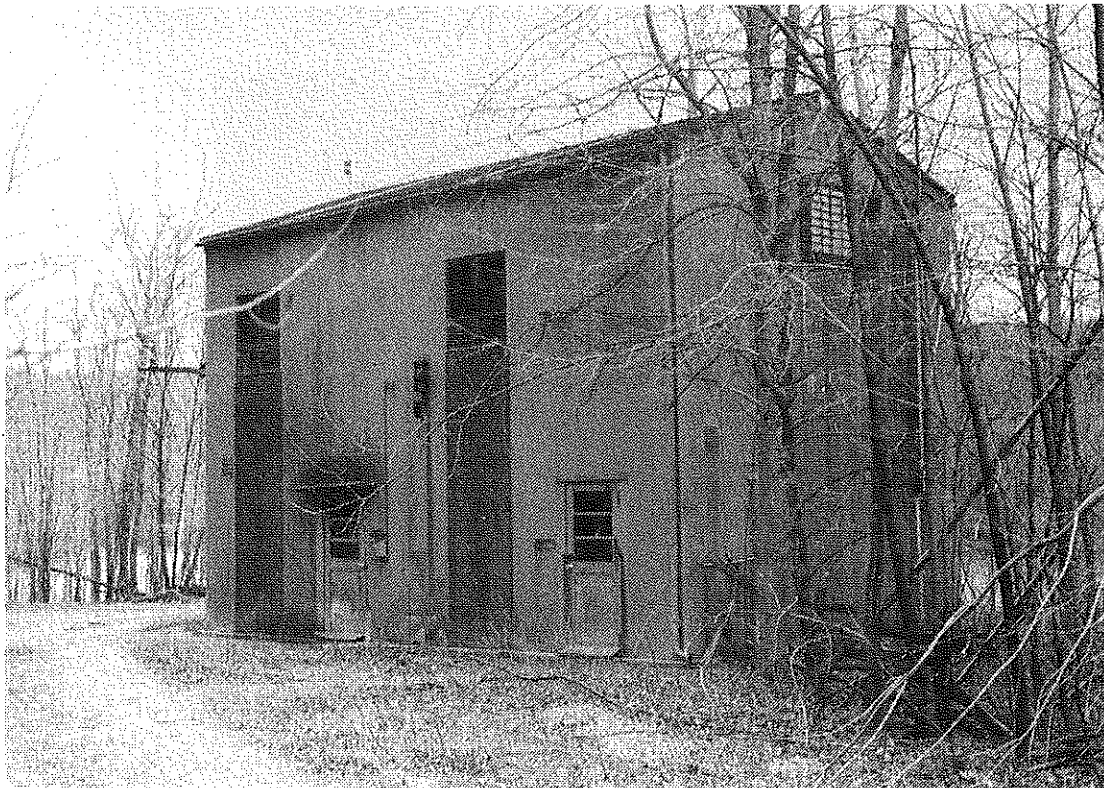
Figure III-10 - Shield Mock-Up Building (1980 photo)

This is a 20' by 30' by 20' high pre-fabricated steel building on a concrete slab, located at the outer edge of the complex. It is 720' north-northeast of the Critical Facility Building and was constructed in late 1957 (7, 20, 46).

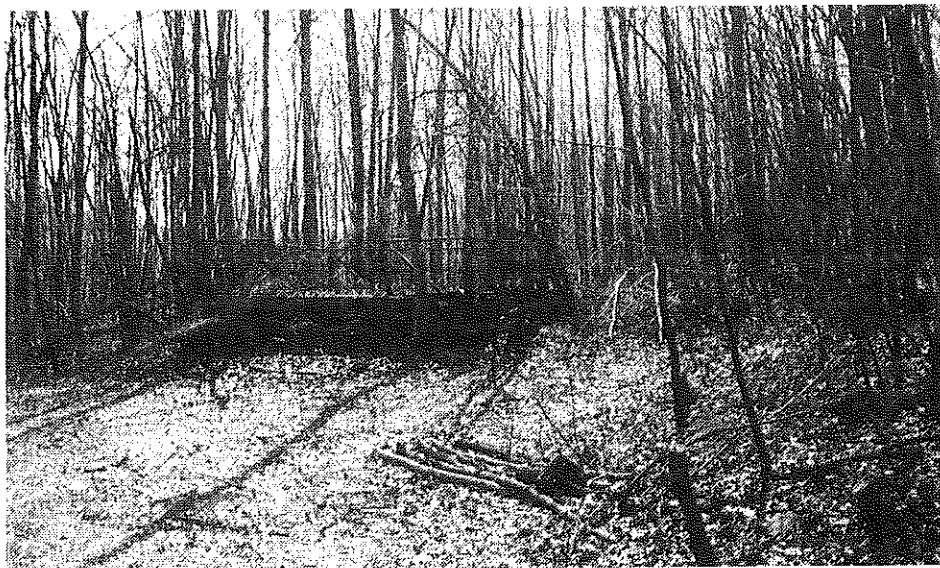
Figure III-11 - Sodium Storage Tent (1980 photo)

The sodium tent is a 15' by 15' concrete pad on a concrete block foundation, located about 1000 feet north of the Critical Facility Building. The floor was sheet steel with a tent erected over it and wood railing along the sides. It was constructed in 1958, and required considerable clearing of vegetation around it to reduce the fire hazard (47, 56).
